Removal Action Summary Report
WAIMANALO GULCH SANITARY
LANDFILL

KAPOLEI, O'AHU, HAWAI'I

AUGUST 2011

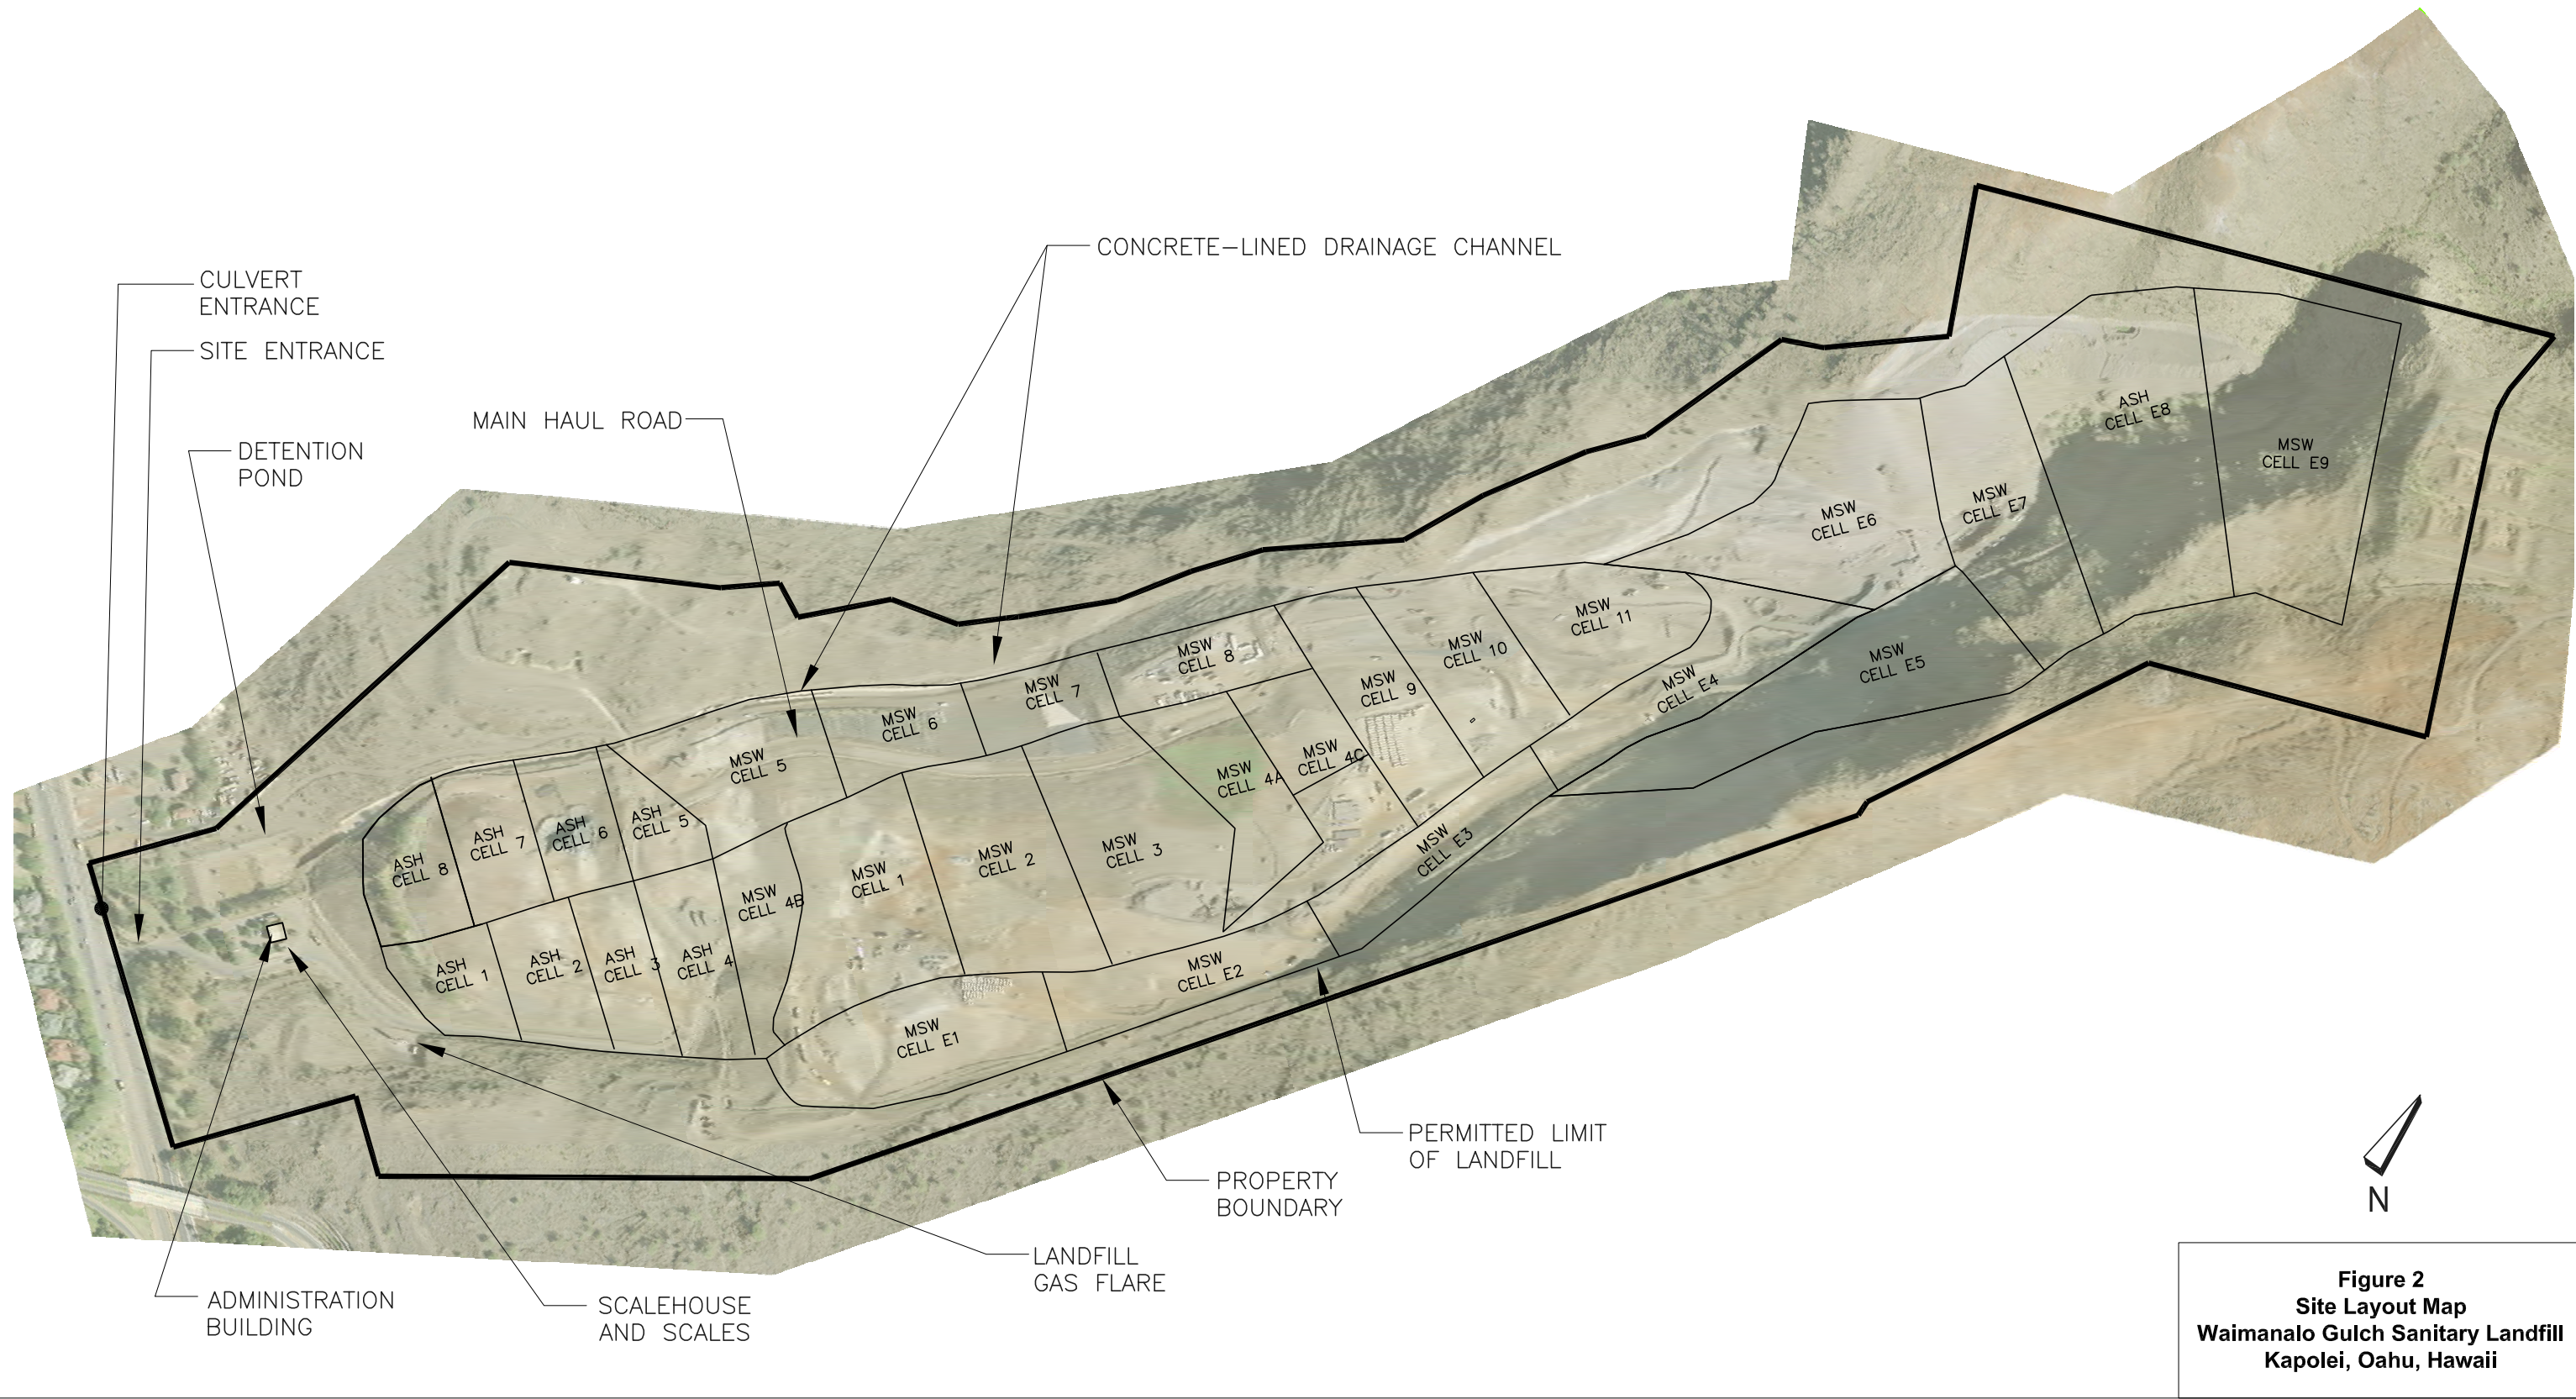
Figure 2
Site Layout Map
Waimanalo Gulch Sanitary Landfill
Kapolei, Oahu, Hawaii

NOTES
1. DATE OF FLIGHT: JUNE 7, 2010
2. PROPERTY BOUNDARY AND CELL LOCATION APPROXIMATE

The Waimanalo Gulch Sanitary Landfill (WGSL) is an active municipal solid waste (MSW) disposal facility located at 92-460 Farrington Highway in Kapolei, Oahu, Hawai'i and is owned by the City and County of Honolulu (City). Waste Management of Hawaii, Inc. (WMH) is contracted by the City to manage and operate the landfill. WGSL is the only operating municipal solid waste landfill (MSW) on the island of Oahu and receives commercial and residential wastes generated within Oahu, as well as ash and residue from the H-Power power plant. See Figure 1 for a site location map and Figure 2 for a site layout map.
